NATIONAL AUDIT OFFICE

PERFORMANCE AUDIT REPORT  
DISTRIBUTION OF ELECTRICITY IN THE  
GREATER BANJUL AREA  
BY  
NATIONAL WATER AND ELECTRICITY  
COMPANY (NAWEC)

MARCH 2017

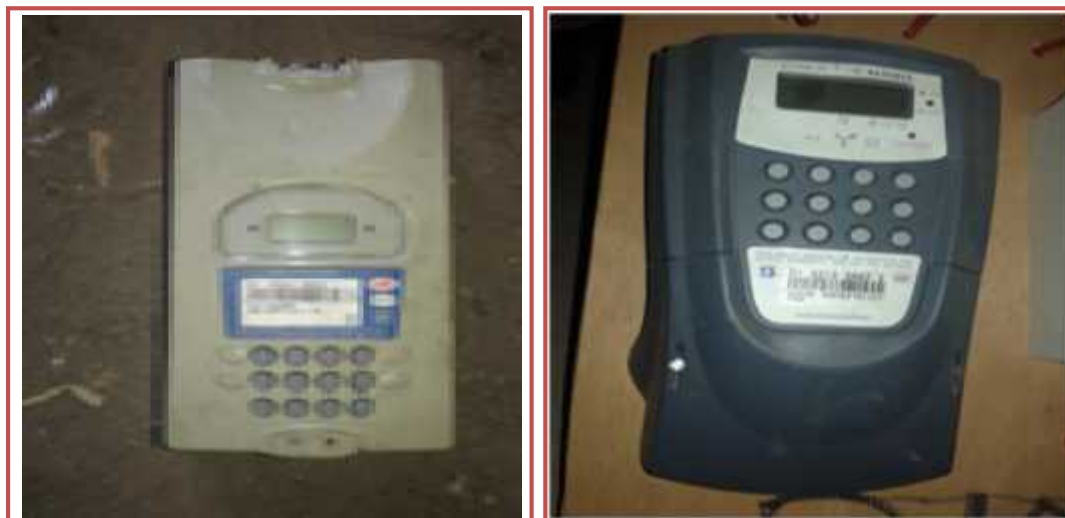
Picture 3 showing the sample of the meters that were purchase in 2011

Discussion with management revealed that these meters were installed to residence of customers. However, some of the meters especially the single faced were recalled from the system because of fault noted by customers through the company's meter reading

unit. The faulty meters were collected and dismantled by the company. We could not establish how many of these single faced meters were actually recalled from the system for this particular procurement, as there was no specific record to show the number of faulty meters that were recalled from this consignment.

Management attributed the cause of these faults to power fluctuation or power cuts experienced in the GBA especially in the City of Banjul and densely populated towns of Kanifing Municipality and Brikama. According to the management of the company, these meters were tested in the provinces or rural areas and they performed well which was one of the basis of ordering them. The supply pattern of the electricity by the company proves that, the supply of electricity in the rural areas is fairly steady. Therefore testing these products only under such circumstance or conditions might not be a fair test for proving their resistances and condition of service. These materials would have been tested also in the City of Banjul and densely populated towns of Kanifing Municipality and Brikama, which would have facilitated a proper evaluation and availed management of the company to make informed choices based on the resistance and condition of service of these meters

In the absence of Technical Compliance Certificate, we could not ascertain whether proper testing of meters was done in order to ensure that they are compatible to NAWEC's existing system.

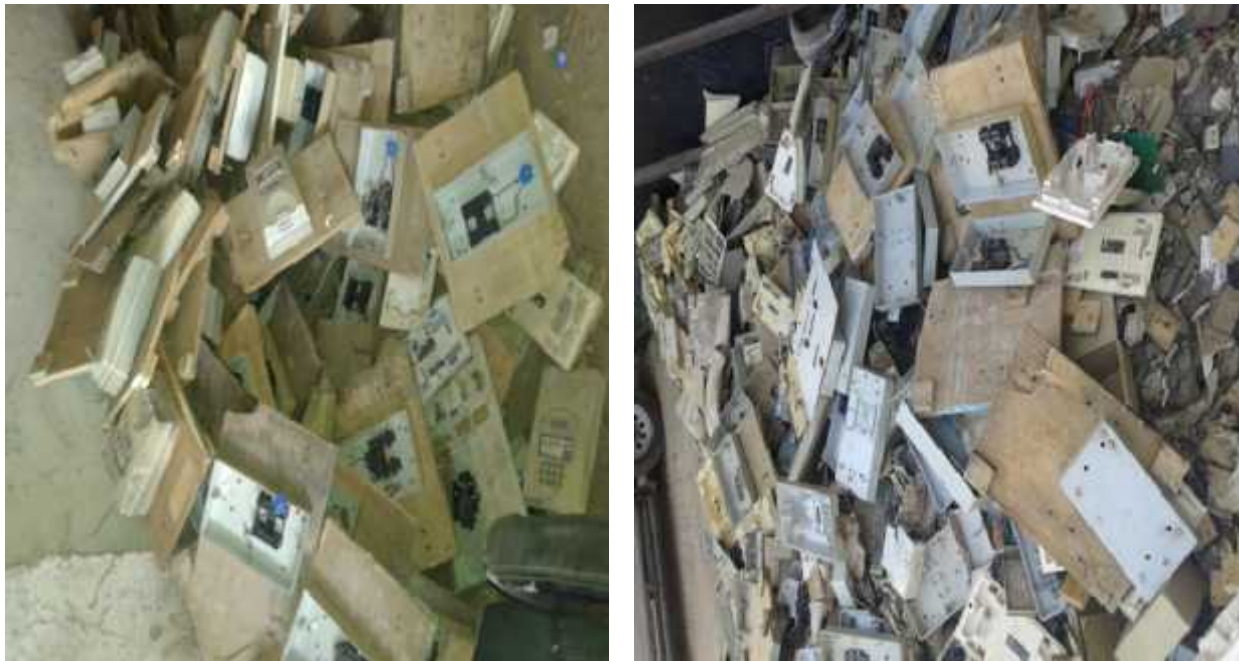
**Picture 4:** Showing recalled and dismantled meters kept in stores of the Nawec
