**NATIONAL AUDIT OFFICE OF THE GAMBIA**

# **PERFORMANCE AUDIT REPORT**

**THE PROVISION OF WATER IN URBAN, PERI-URBAN AND  
PROVINCIAL GROWTH CENTRES BY NAWEC**

**NOVEMBER 2022**

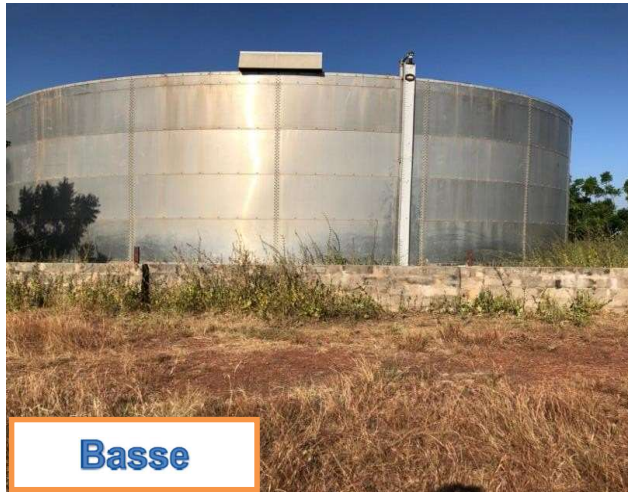
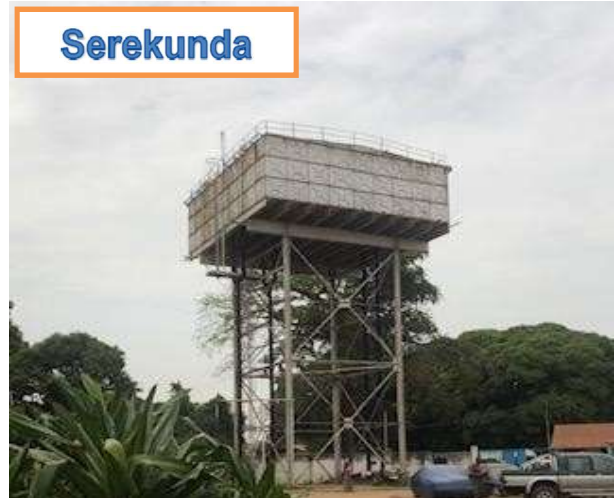
As shown in table 3 above, 44% of the elevated tanks were bypassed due to the excess demand, faulty liners, structural problems, and old age. Some of these causes were corroborated by the water and sanitation in the Greater Banjul Area (WASIB) project feasibility study. Picture 1 shows the non-functional elevated tanks at Basse and Serekunda water treatment plants.

Picture 1: Non-functional water tank at Basse water facility and Serekunda Treatment Plant

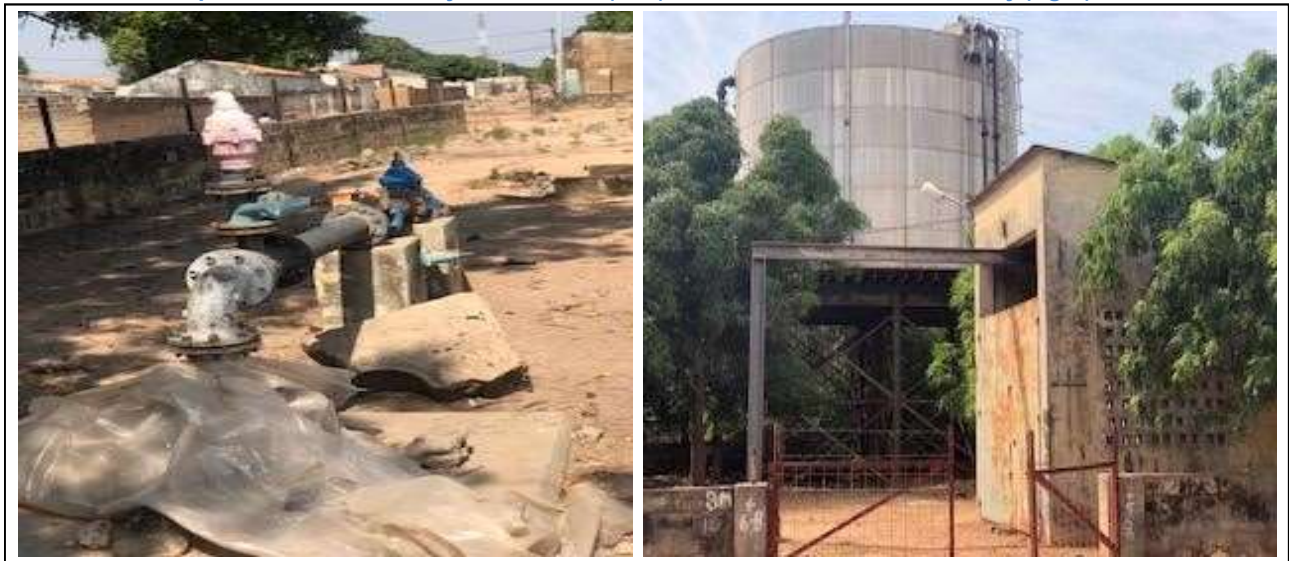
In addition, in Farafenni, animals such as pigs and goats were found intruding in the treatment plant and the operator disclosed that children and animals do cause damages to the cables of the boreholes. During the inspection of the boreholes, we found out that 35 out of the 60 boreholes inspected were not well protected as the gates were damaged or left open as shown in pictures below.

**Picture 2: The unprotected water facility at Farafenni (Left) and Mansakonko water facility (right)**

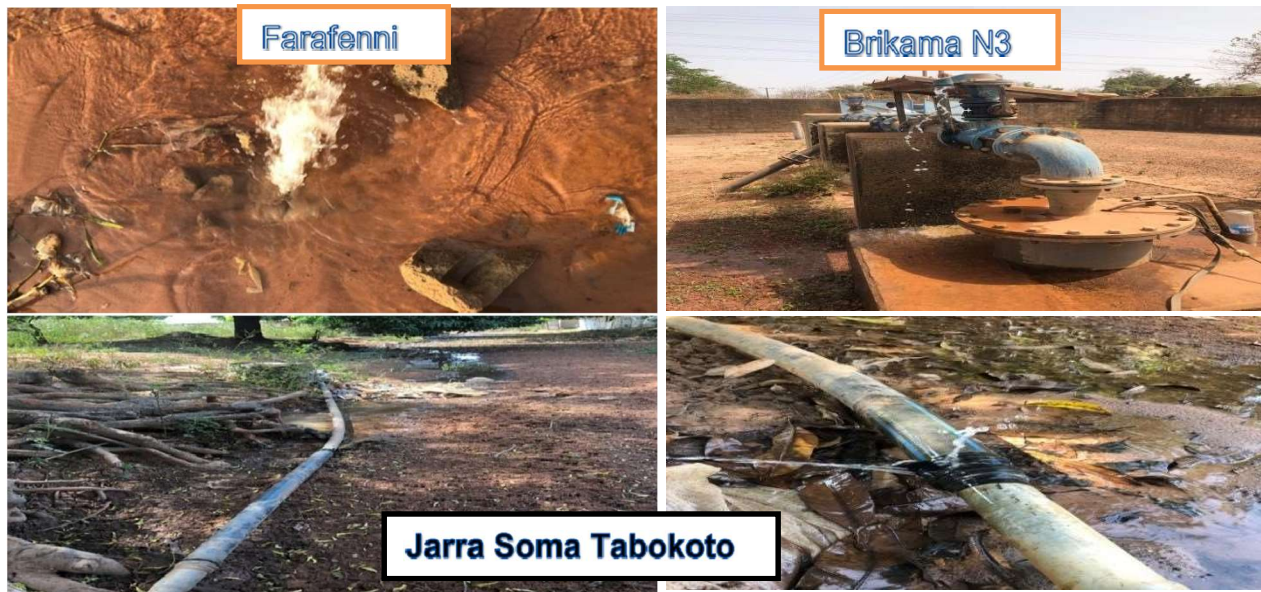
Picture 3: Burst pipes in Farafenni (top) and Mansakonko (down)

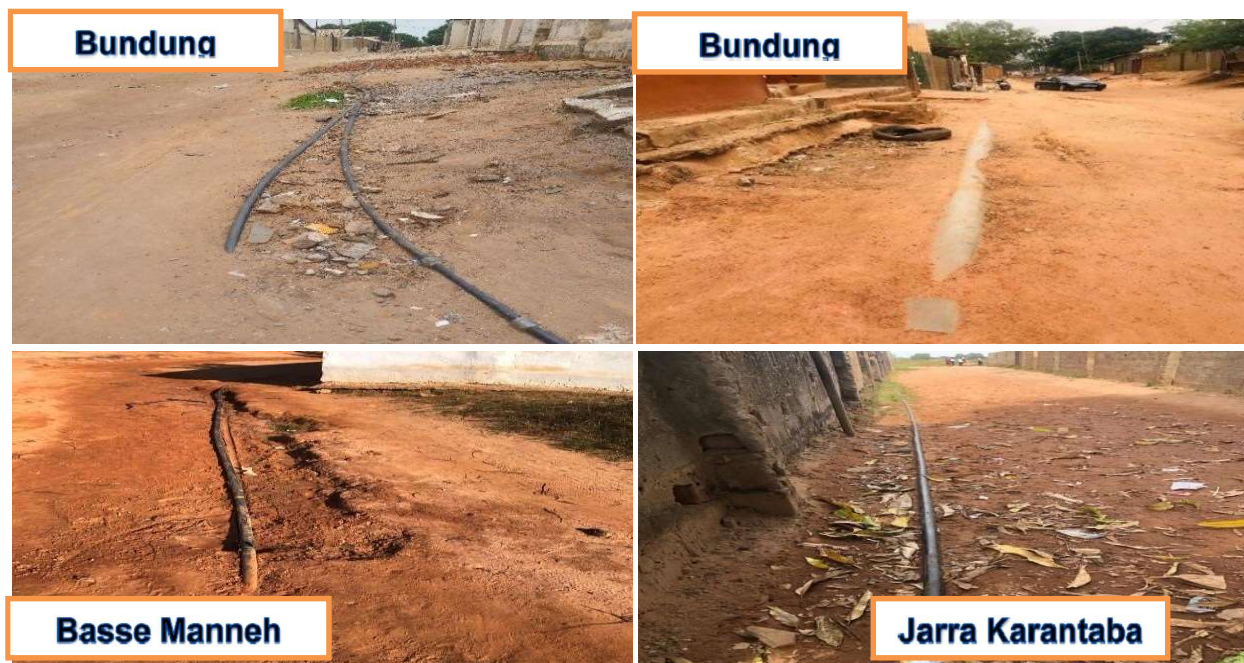
Picture 4: NAWEC's exposed distribution pipe (top Left), main pipe (top right) in Bundung and exposed distribution pipe (Bottom left) exposed distribution pipe at Jarra Karantaba (Bottom right)

NAWEC’s Water Division Management informed us that the exposure is sometimes caused by soil erosion, or the pipes were not laid at the appropriate depth during installation. This assertion was confirmed during our site visits as seen in the above pictures (3 and 4) that pipes were not properly buried as required. In addition, during an interview, the management of Water Division acknowledged that NAWEC has not set up a monitoring team to follow up on its ground works.<sup>40</sup>

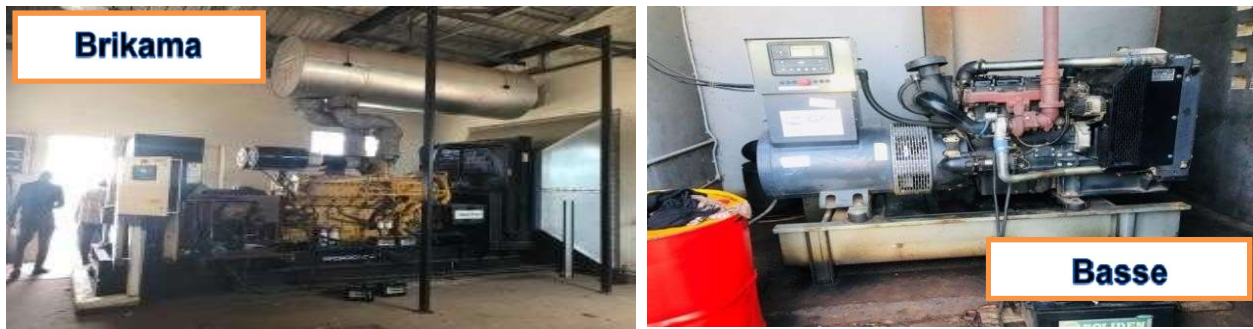
Picture 5: Non-functional Standby Generators at Brikama and Basse water treatment plant.

According to the Water Division management, NAWEC has failed to repair its generators due to financial constraints. However, the audit team was not provided with any document to back this claim.

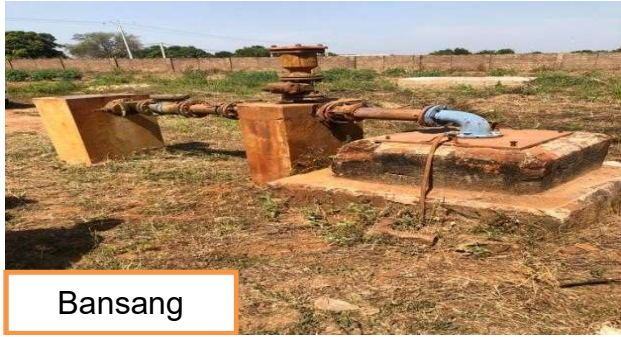
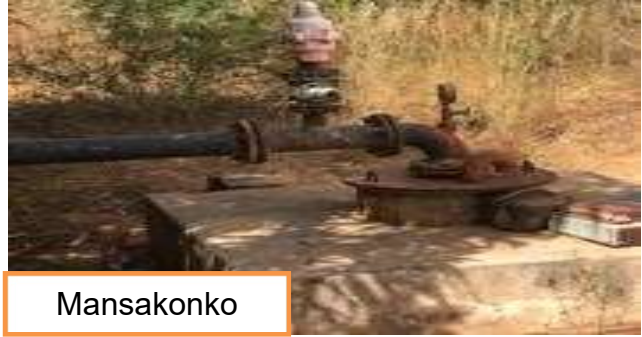
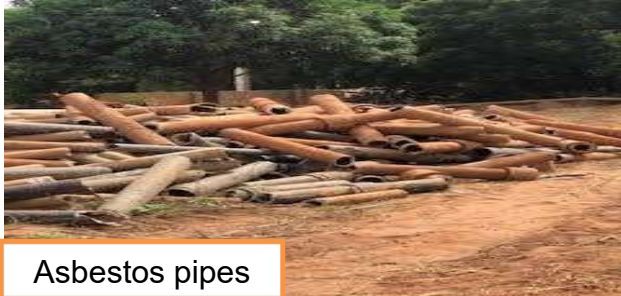
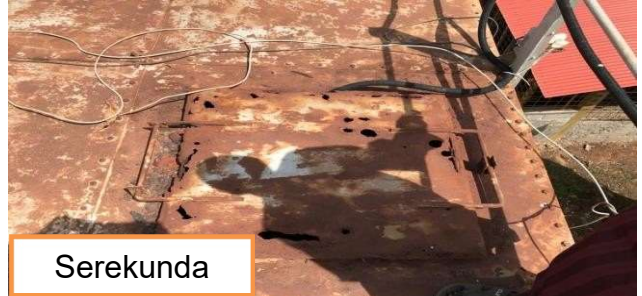
**Picture 6: Corroded boreholes at Bansang water facility (top left) and Mansakonko (top right), some of the replaced asbestos pipes placed at Faraja water treatment plant and reservoir at Serekunda water treatment plant (bottom right)**

This was due to the company's failure to establish strategies for replacing old infrastructures. Corroded aged infrastructures pose a high risk of failure, resulting in service interruptions and water quality with a bad taste, colour and contamination. **Appendix 8:** Showing 74 boreholes and their ages their ages.

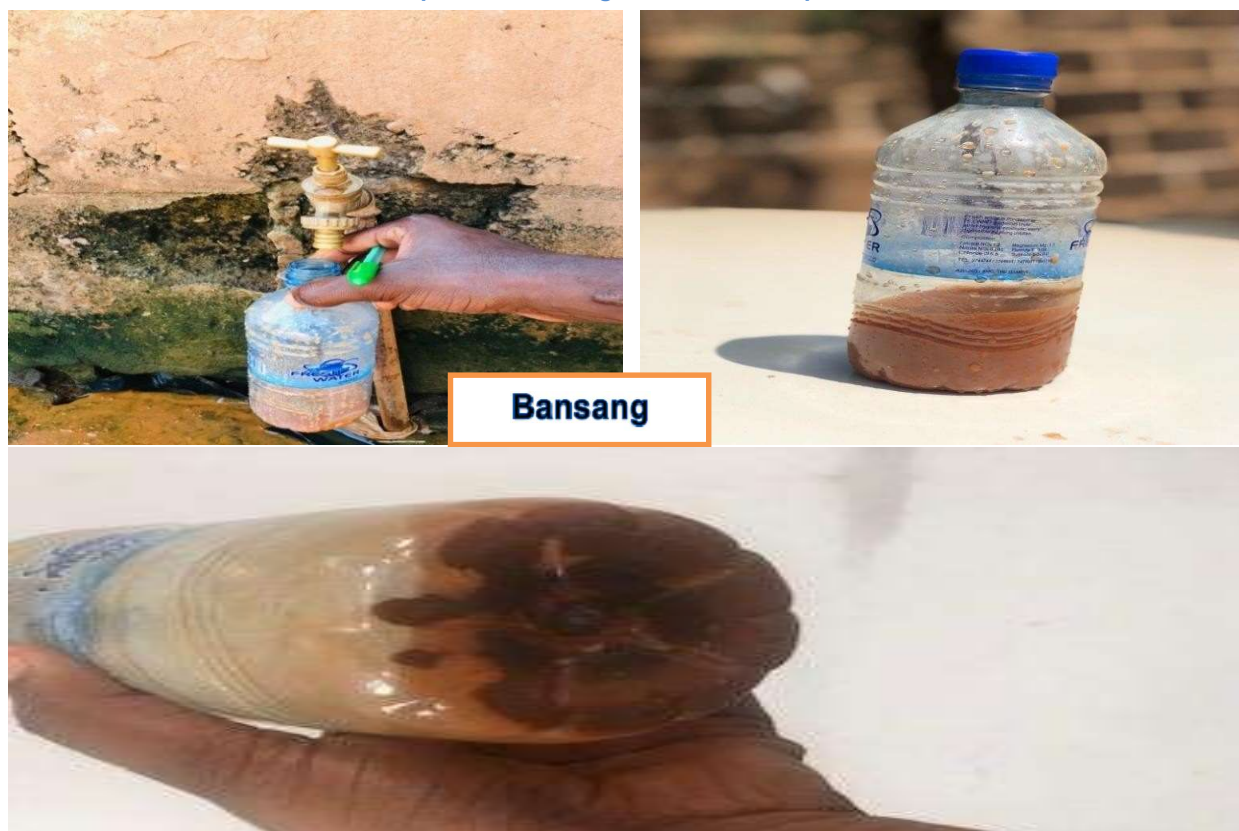
During the inspection of the Bansang Water Treatment Plant, the audit team collected a water sample from a tap inside the Treatment Plant as shown in Picture 7.

Picture 7: Water obtained from the tap in the Bansang water treatment plant

High iron content in water promotes bacterial growth in water production and distribution system, iron overload can cause hemochromatosis in humans which causes damage to the heart, liver and pancreas.<sup>50</sup> Additionally, high iron content causes stains to clothes during laundry.

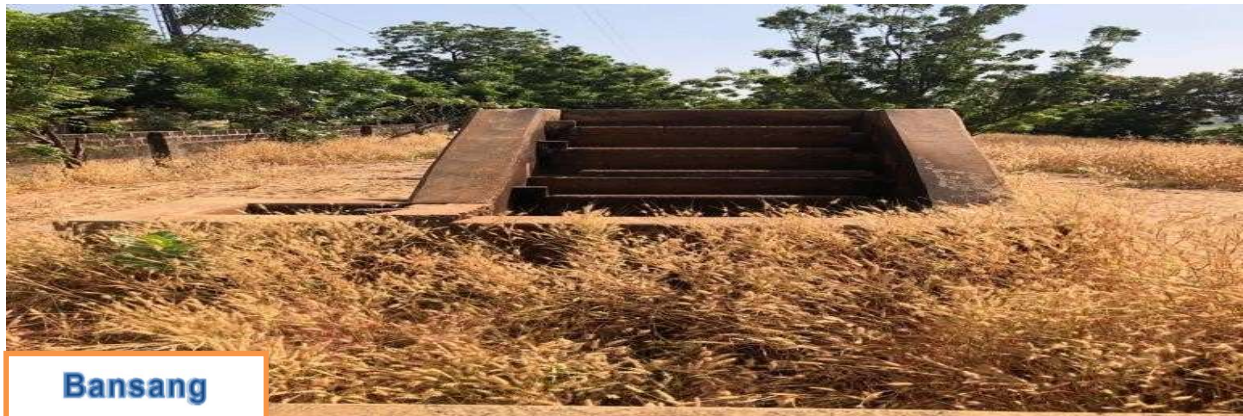
Review of DWR Quarterly Water Quality Monitoring Report revealed that in the third Quarter of 2018, the Bansang water PH level was calculated at 6.57 and this was when aeration was already carried out. However, it was calculated at 5.89 during the second quarter of 2021 when no aeration was carried out during the period. The picture below shows the abandoned aerator at the Bansang Water Treatment Plant.

**Picture 8: Abandoned aerator at Bansang Water Treatment Pant**

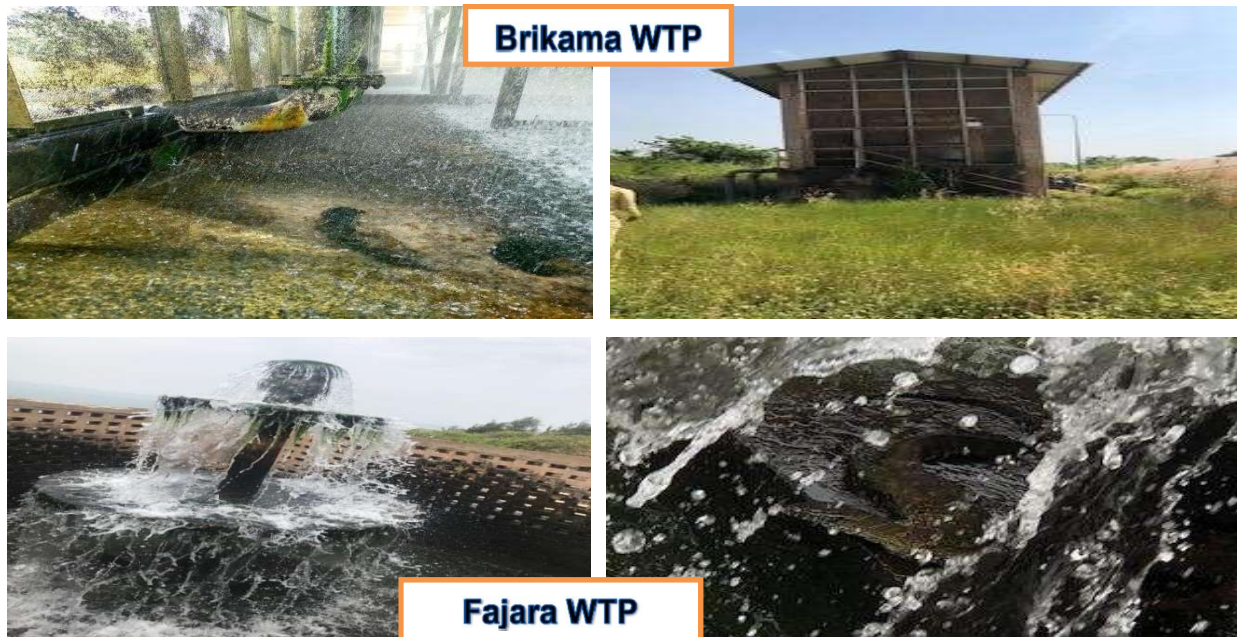
The unhygienic condition of the water facilities poses a high risk to the health of the consumers as the water is exposed to contaminants such as disease-causing microbes (bacteria). Exposed and unenclosed aerators attract birds, animals, reptiles, harmful objects, and bacteria; these can lead to water contamination and a high risk of supplying contaminated water to the population.

**Picture 9: Condition of the aerator at Brikama Water Treatment Plant (Top left and top Right) and aerator condition at Fajara Water Treatment Plant showing a reptile (Monitor Lizard) inside the aerator.**

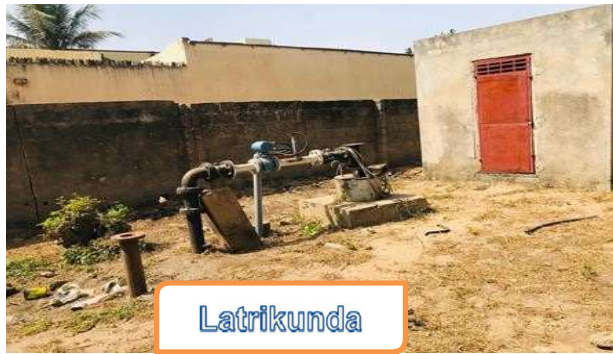
Latrikunda

**Picture 10: NAWEC boreholes encroached by settlements (Top left PN6(Sinchu), Top right BH12 (Jola Kunda) and BH 18(Latrikunda) all link to the Serekunda WTP and down right is SS6 of Sukuta WTP.**

According to the Deputy Director of DWR, human activities such as the digging of toilets and soakaways deeper than two meters, and improper waste disposals by encroachers lead to borehole contamination by nitrate. However, Fajara Treatment Plant is getting some of its water supply from Sukuta Treatment Plant. Additionally, NAWEC does not have any nitrate treatment procedure in place to reduce the level of nitrates in its water. The chart below shows the percentage level of boreholes encroached.
