NATIONAL AUDIT OFFICE

PERFORMANCE AUDIT REPORT
SOLID WASTE MANAGEMENT
BY
BANJUL CITY COUNCIL (BCC)

OCTOBER 2015

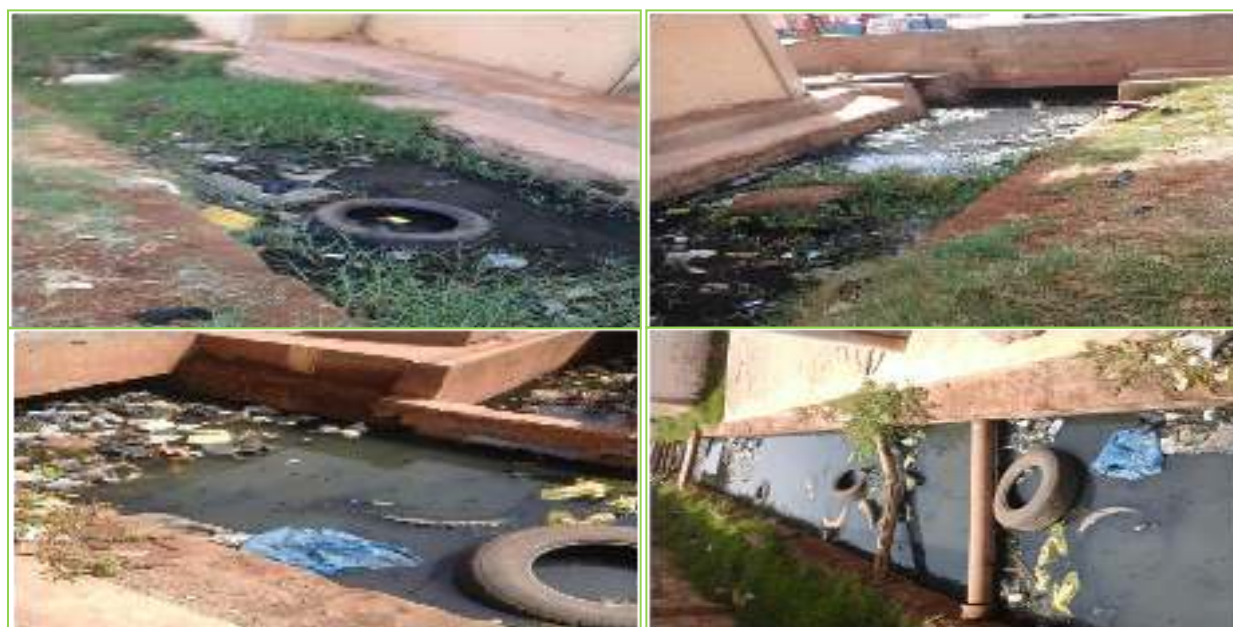
Picture 2: Showing waste dumped in the drains at Mosque Road

Streets in the city such as, Tobacco road, Grant Street, Box Bar road, Mosque road and Half Die where drains have been turned to un-official dumping places were also visited.

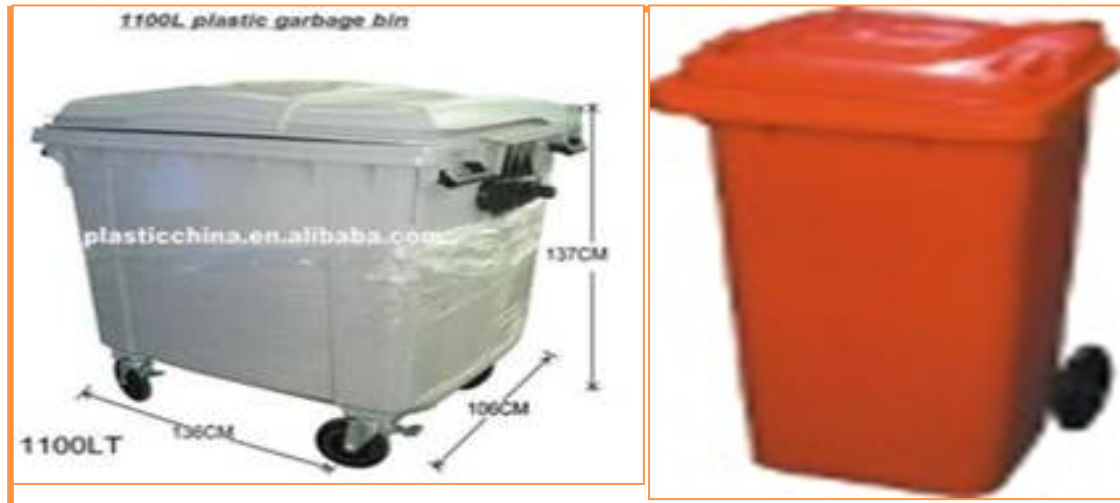
Picture 7: Showing the different types of waste receptacles

address the large volume of waste that would be deposited by the very many street users of the city on a daily basis. Picture 7 below depicts the differences between the two receptacles:

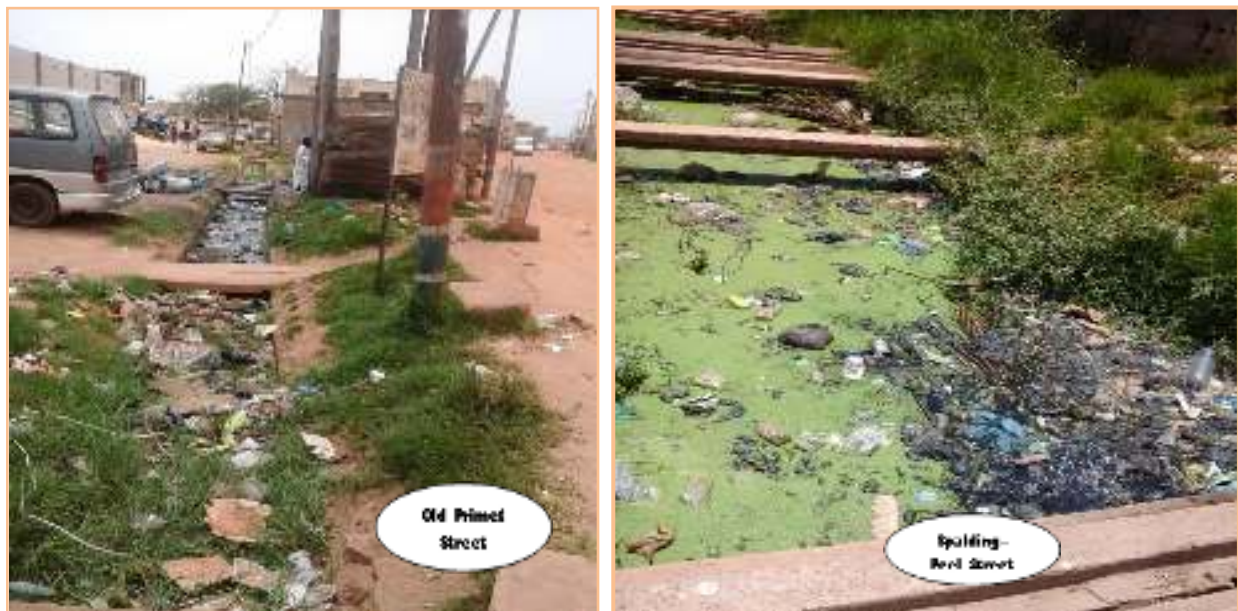
Picture 8: Showing un-collected wastes inside the gutters in Banjul

Consequently, the uncollected waste continued to pile up in the city centre and If not collected, could be blown away by the wind into the drains obstructing drainage as shown in Picture 8 below. This waste in the gutters can be a trigger for floods considering the heavy rains The Gambia has experienced in recent years. In addition, the stagnant water serves as a breeding home for mosquitoes and a sanctuary for rodents, vectors like flies and mosquitoes and other unwanted elements that carry diseases.

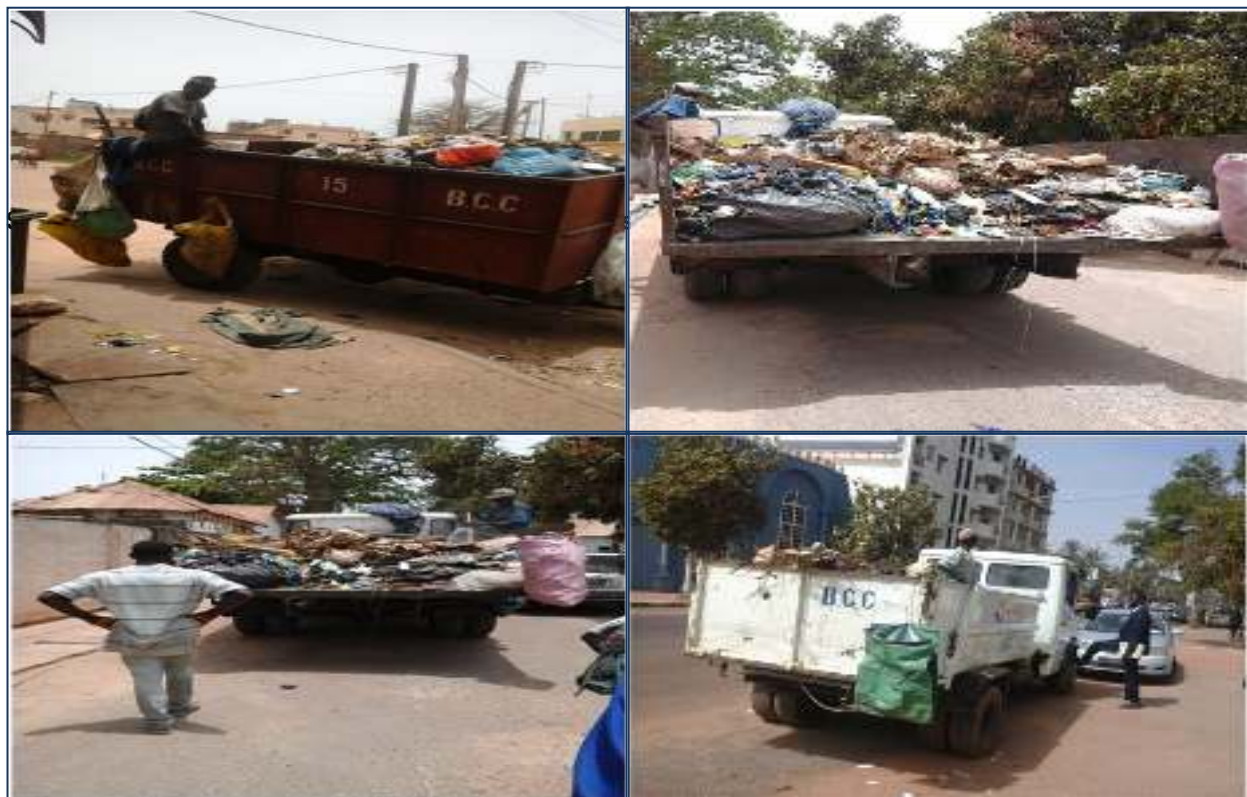
Picture 9: Showing uncovered cleansing vehicles carrying waste to the dumpsite

The audit noted that the council used trucks and tractors which were not covered or structured to carry waste without dropping. During a field visit by the audit, 3 BCC trucks and a tractor were seen carrying waste without being covered. The trucks and the tractor are shown in picture 9 below:

The council management attributed the use of these carriers to inadequate funds to acquire standard cleansing vehicles. According to the Waste Manager, the Waste Management Unit should have twelve (12) vehicles, comprising five (5) tipper tractors, five (5) tipper Trucks and two (2) mini tipper trucks to collect and transport the waste

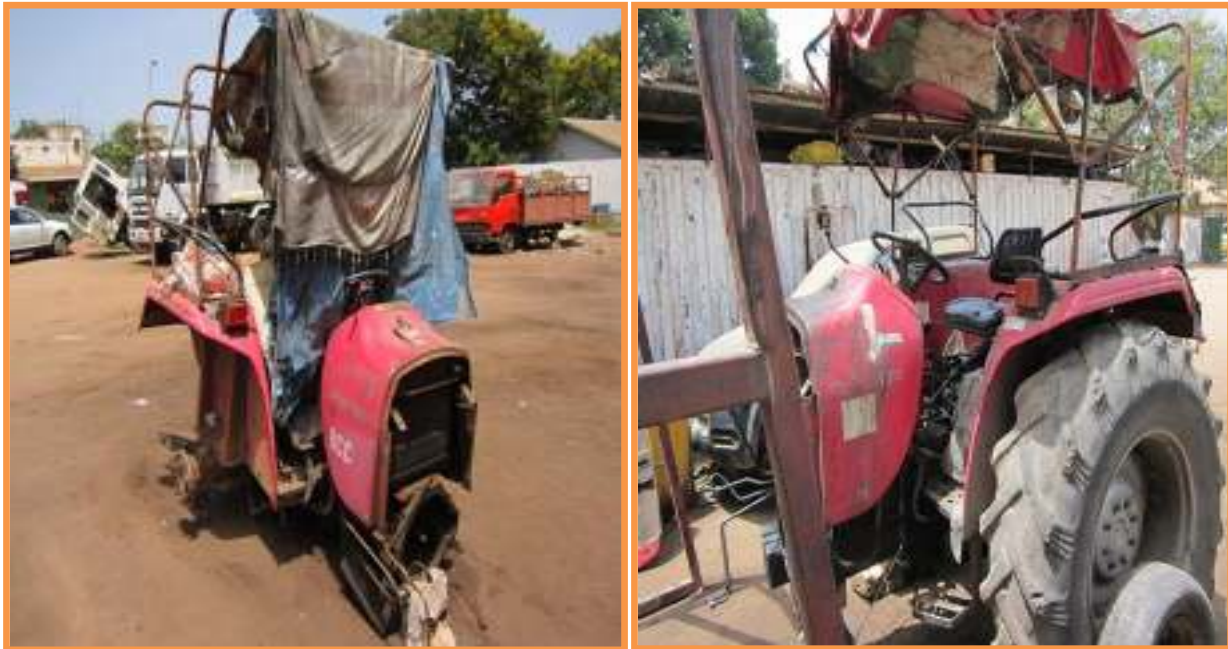
Picture 10: Showing the two confirmed tractor heads at BCC

The audit noted that the Council bought seven (7) Tractors to be used by the waste management unit to collect household waste on a daily basis. However, out of these seven Tractors, the audit was only able to verify the existence of two (2) Tractors. The audit could not establish the existence of the remaining 5 Tractors. Further inquiries with management to establish the whereabouts of these 5 Tractors also proved futile. Details of the transaction in respect of this procurement are shown in table 8 below:

- ❖ The Management of the City Council must explain the circumstances surrounding the accountability of the 5 (five) tractors that could not be located by the auditors.
- ❖ The BCC management must explain and produce the auction file containing Engineer's report on the status of the auctioned vehicle, the valuation report of the vehicle, the details of the Valuer, and details of the auctioneer.
- ❖ The City Council should ensure that there is a Maintenance plan in place to help sustain the fleet of cleansing vehicle and should make effort to replace the dilapidating vehicles.
- ❖ The council should consider, acquiring tipper vehicles, which will reduce the amount of time taken in the loading and offloading of waste.

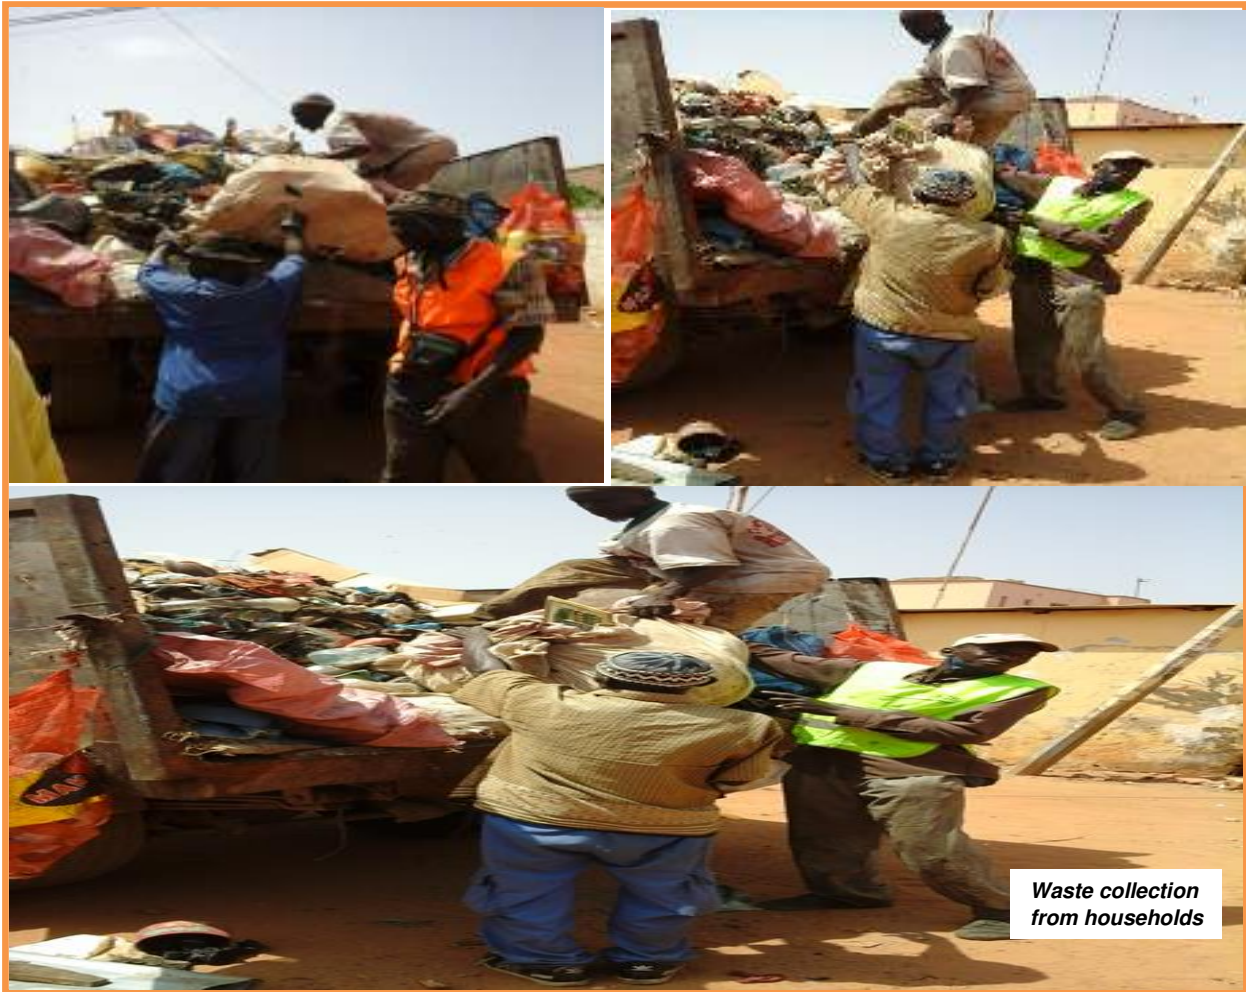
Picture 11: Showing Manual loading of waste on waste trucks by BCC Labourers

We also noted that the cleansing vehicles used in the transportation of the waste collected in the city were manually loaded at the collection zones and offloaded by the labourers at the dumpsite using forks. Each cleansing vehicle was allocated with only 2 forks for loading and offloading of waste.

all the waste generated in the city on a daily basis. The pictures below capture the manual loading of garbage onto waste trucks by BCC Labourers:

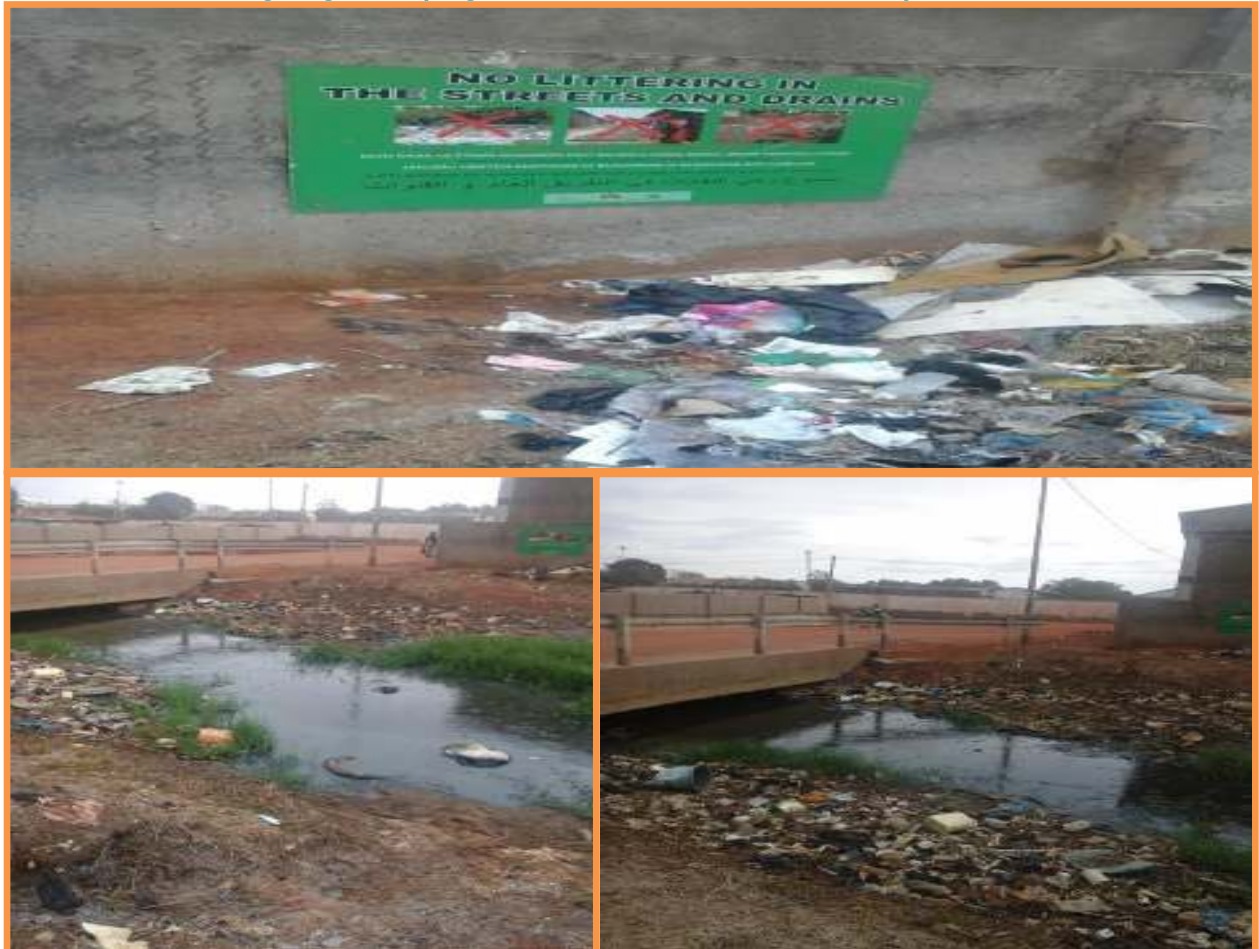
Picture 13: Showing illegal dumping of waste at Tobacco Road in Banjul

the city, and found waste being dumped around houses/buildings which were not designated areas for dumping of waste.

In addition, the audit did not find street receptacles and trailers for waste collection placed at these streets and collection spots in the zones for waste dumping. The picture below shows waste dumped around buildings and back streets at places we visited in the city.

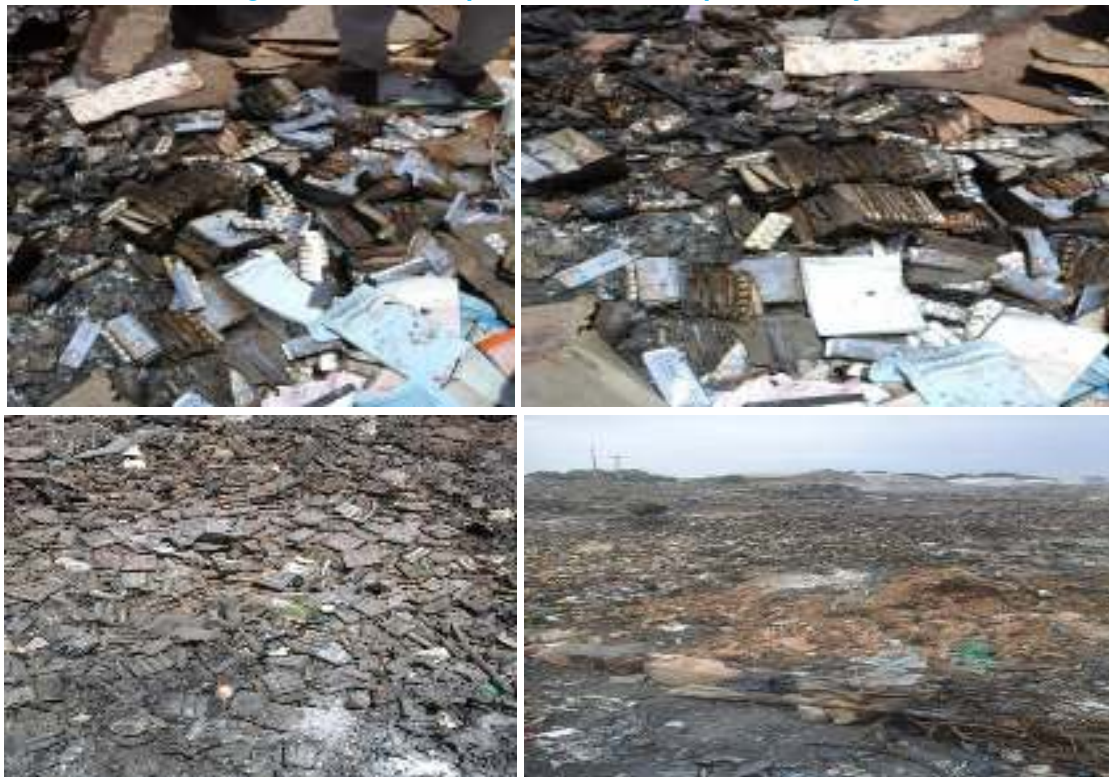
Picture 15: Showing mixed waste deposited at the dumpsite in Banjul

The audit noted that the waste deposited at the dump site was not separated by the Council. For example, a site visit to the City Council dump site revealed that clinical, wet, dry and other types of wastes were put together with household waste and deposited at the dump site. The BCC should employ appropriate methods of waste treatment techniques for the handling of its waste such as, sorting waste into recyclables and non-recyclables. The picture below shows mixed waste deposited at the BCC dumpsite.

- ❖ The council should consider burning waste by using an incinerator which controls burning and prevents environmental pollution.
- ❖ The council should consider adopting the practice of sorting waste to facilitate recycling.

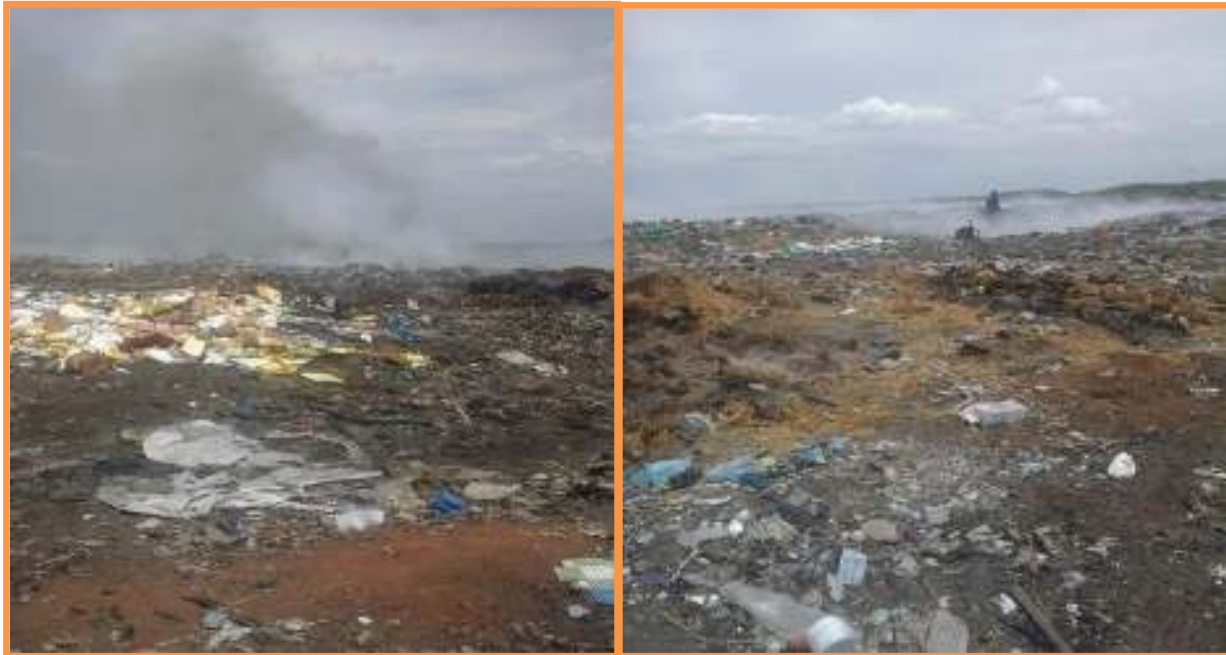
Picture 16: Showing Dump site set ablaze

Similarly, we observed that the waste deposited at the dump site was openly set ablaze. Large clouds of smoke were emitted and this pollutes the environment around the dump site including State Central Prison, Banjul/Serreunda Highway and Sanatorium (a wing of the main hospital where tuberculosis patients are kept). The team, during the site visits

took photographs at the dumpsite showing instances where the waste dumped is set on fire. The pictures are shown below.

Similarly, the large clouds of smoke emitted from this open burning of waste equally pollutes the air to the inconvenience of the residents around the dumpsite, obstruct the flow of traffic and can also cause health problems.

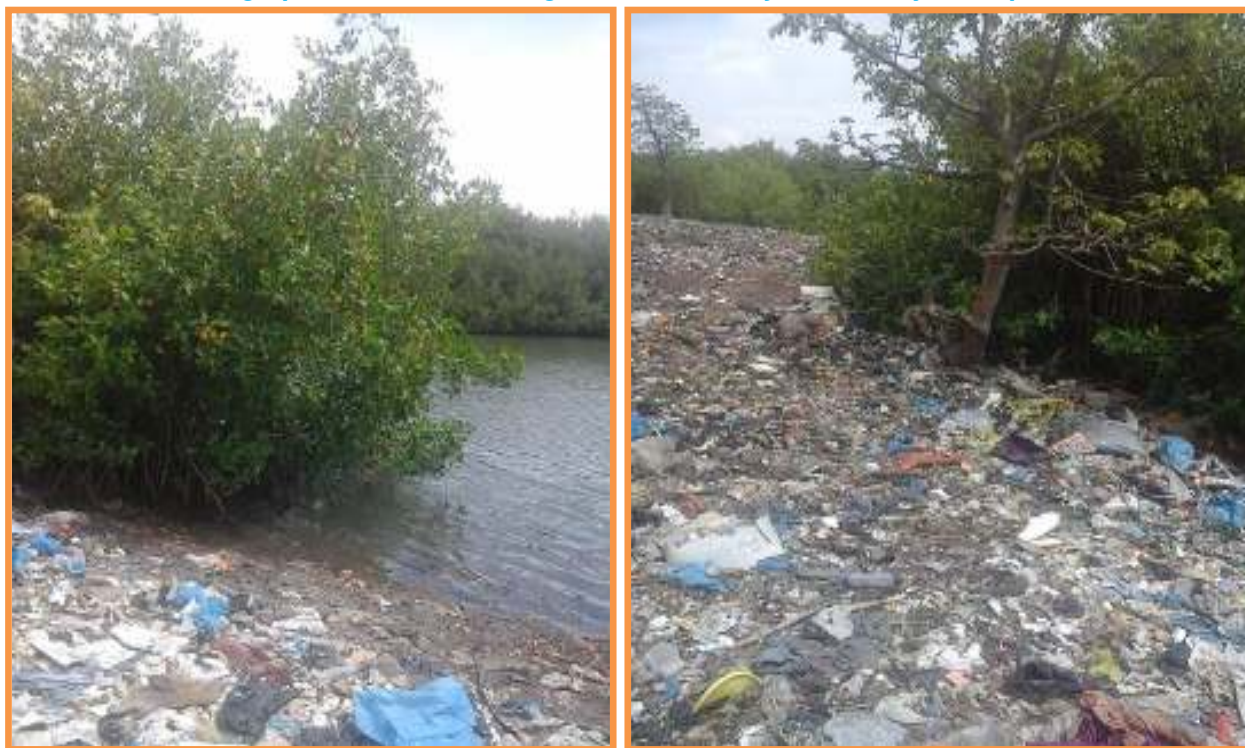
Picture 17: Showing Spread waste intruding into the tributary at the Banjul dumpsite

In addition, waste deposited at the dump site is spread out by the Council Waste Management Staff. However we noted that the dump site area was not fenced and the waste spread gets into the waters of the tributary of the ocean which it borders with. The intrusion of this waste into the water is likely to pollute it which may affect the aquatic species e.g. fishes that are likely to feed in this water. For the fact that the dump site is not fenced, light waste such as papers, nylons, and plastic deposited at this dumpsite and the odour emitted by the spread waste are blown away by the wind into the neighbourhood of the Mile 2 state prison and Sanatorium. The picture below shows spread waste intruding into the tributaries of the ocean.
