**NATIONAL AUDIT OFFICE OF THE GAMBIA**

# **PERFORMANCE AUDIT REPORT**

**THE PROVISION OF WATER IN URBAN, PERI-URBAN AND  
PROVINCIAL GROWTH CENTRES BY NAWEC**

**NOVEMBER 2022**

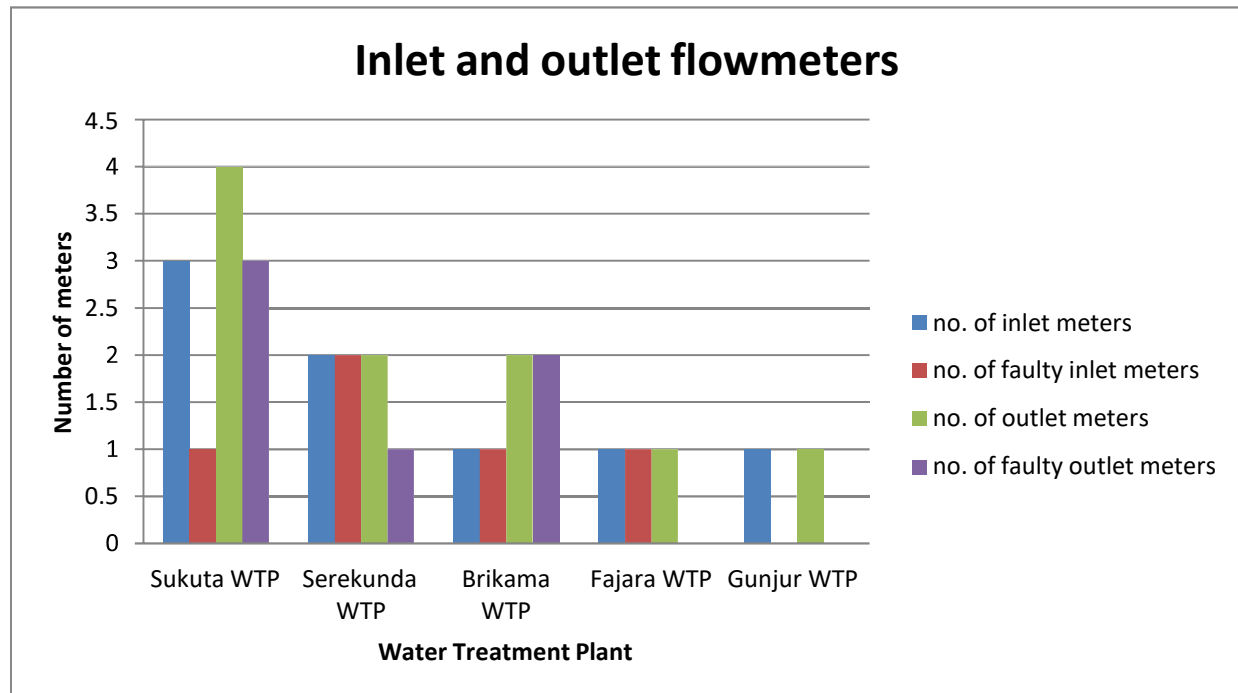
Chart 6 : Number of fault outlet and inlet flowmeters at water treatment plants and elevated tanks.

Furthermore, during an inspection of the inlet and outlet bulk water meters at the water treatment plants, the audit team noted that 11 out of 18 meters were faulty (5 inlets and 6 outlets). The functionality of flowmeters is shown in chart 6.

Additionally, an inspection of the inlet and outlet meters of 27 elevated tanks revealed that 15 elevated tanks had faulty inlet meters, 5 did not have inlet meters and 19 had faulty outlet meters.

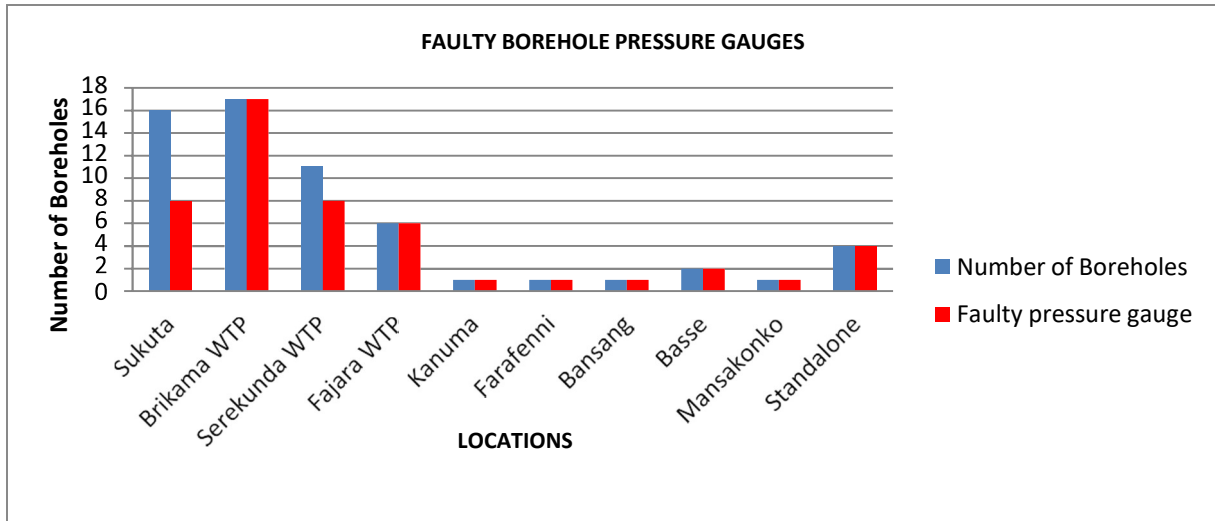
**Chart 8: Number of NAWEC boreholes pressure gauges and the faulty pressure gauges.**

Analysis of chart 8 above shows that 49 (representing 82%) of the pressure gauges installed at the boreholes were not working

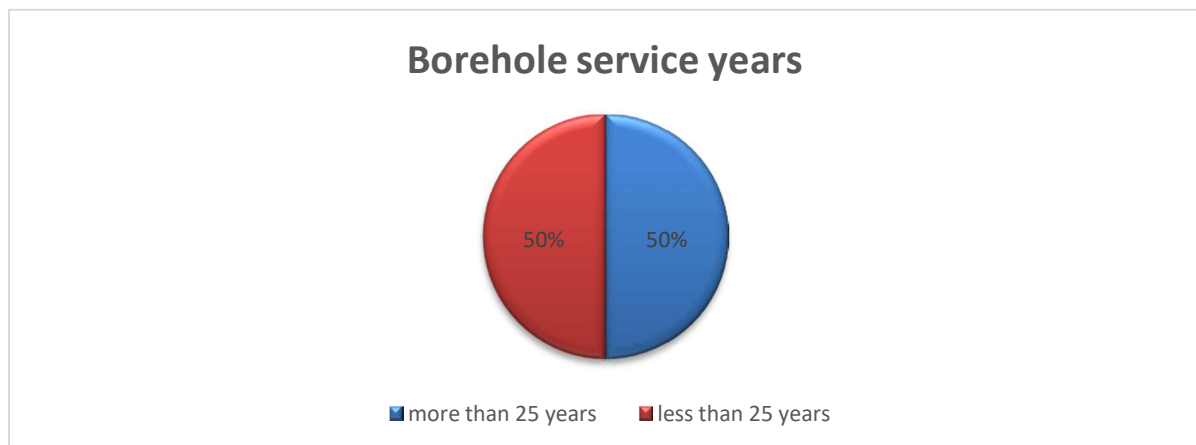
Chart 9: Borehole service years of 74 boreholes.

This was due to the company's failure to establish strategies for replacing old infrastructures. Corroded aged infrastructures pose a high risk of failure, resulting in service interruptions and water quality with a bad taste, colour and contamination. **Appendix 8:** Showing 74 boreholes and their ages their ages.

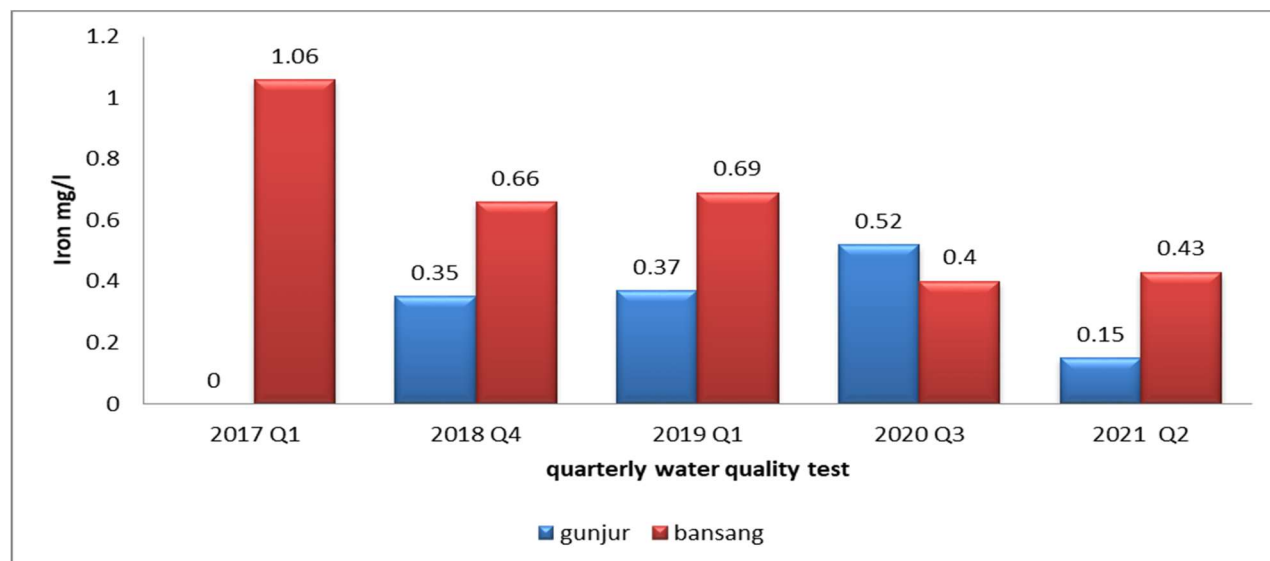
**Chart 10: Iron content in the water supplied to Bansang and Gunjur**

The review of a sample of Quarterly Water Quality Test Reports by DWR during the period under review revealed that, despite the iron filtration system in Bansang, the water in Bansang continued to contain high levels of iron above the WHO standard for drinking water quality. Meanwhile in Gunjur, the iron content has been higher than the acceptable level in 2018 to 2020. However, in 2021 both the first and second quarter Water Quality Test Reports by DWR showed that the iron content in the water sample tested from Gunjur were below the acceptable level.

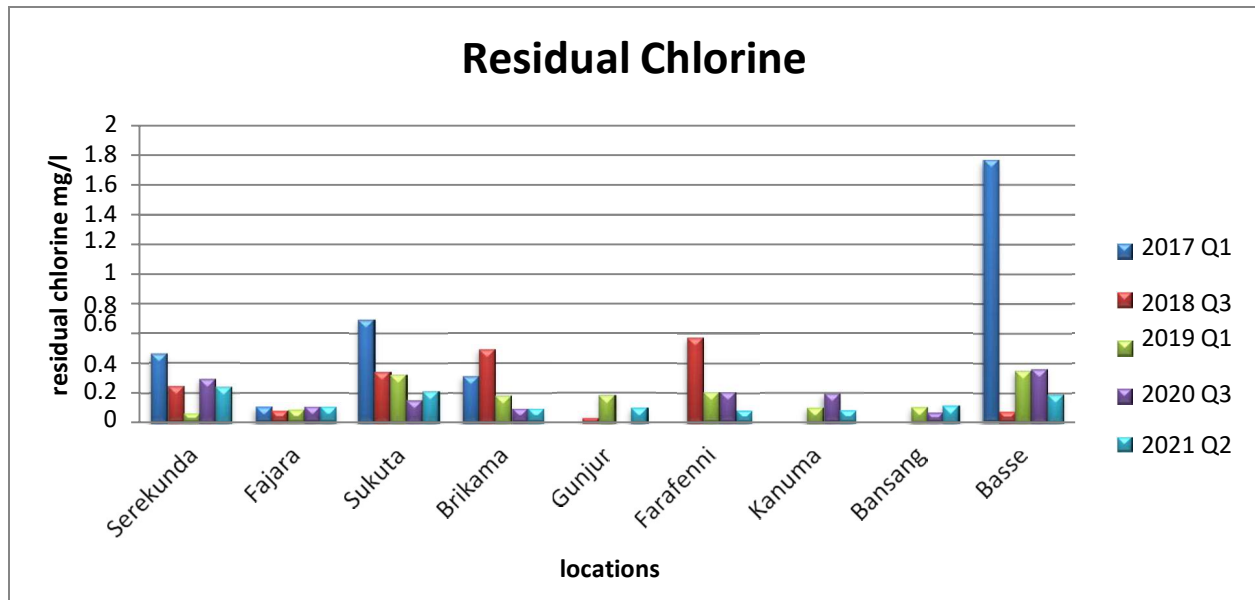
Chart 11: Residual chlorine test result in 85 locations in 2017 and 100 locations from 2018 to 2021.

Review of a sample of the Quarterly Water Quality Monitoring Reports prepared by the Department of Water Resources between 2017 to 2021 showed that an average of 76% of 100 locations tested did not meet the required minimum standard of residual chlorine in the water samples. Analysis of 5 samples of quarterly water quality tests presented is in the chart below.

Further analysis of the quarterly water test results during the period under review showed that the water sample of an average of 16 locations had no residual chlorine.

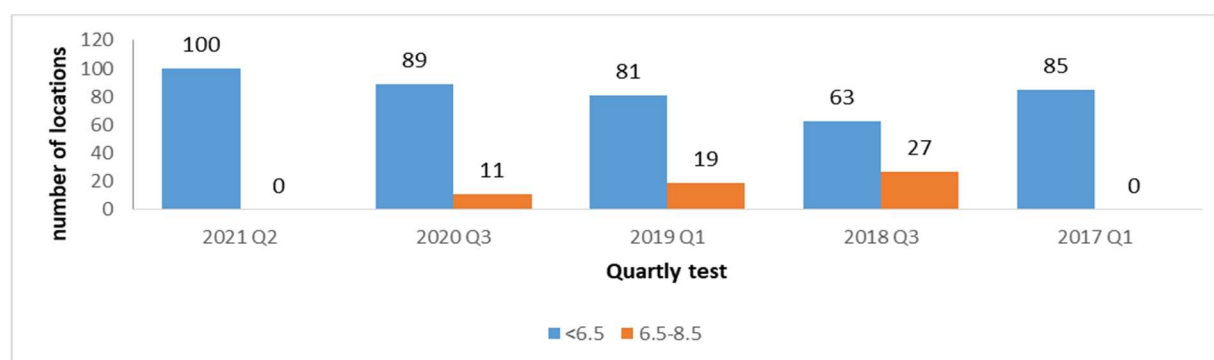
**Chart 12 : Number of locations with pH level below/above WHO guideline of 6.5 to 8.5. in 85 locations in 2017 and 100 locations were tested from 2018 to 2021**

Review of Water Quality Reports by Department of Water Resources during the period under review showed significant number of locations that do not fall within the appropriate PH range. The analysis is presented in the chart below.

As shown in chart 12 above, more than half of the locations water supply have pH levels below the WHO standard. Aeration is carried out to regulate the pH level to an appropriate range. According to NAWEC’s Greater Banjul Area Water Supply System Operating and Maintenance Manual; in case the pH value after aeration is not yet sufficient, lime dosing is applied for further pH adjustment. Therefore, the main purpose of lime dosing is to raise the pH level of water and precipitate the ions (e.g calcium, magnesium, and iron) that cause hardness in water<sup>53</sup>.

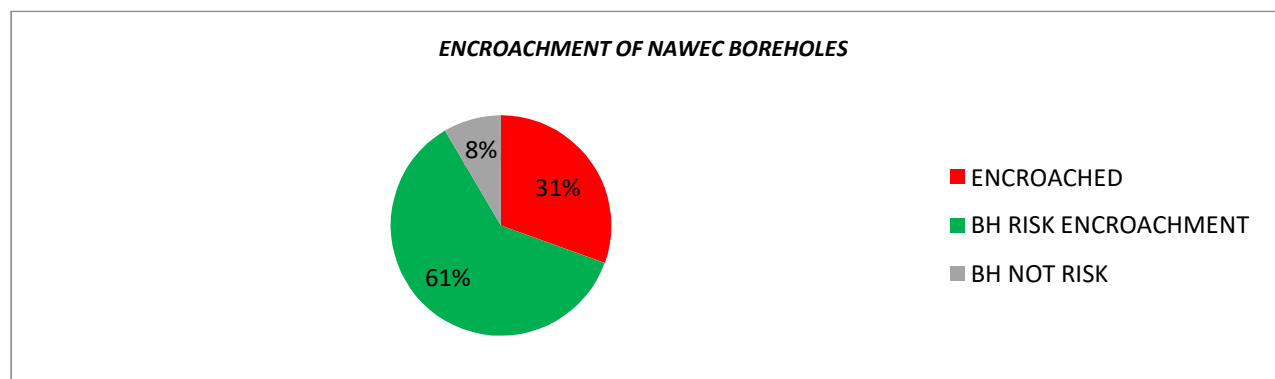
Chart 13: Percentage of boreholes encroached, those that are on risk and those that are free from encroachment.

According to the Deputy Director of DWR, human activities such as the digging of toilets and soakaways deeper than two meters, and improper waste disposals by encroachers lead to borehole contamination by nitrate. However, Fajara Treatment Plant is getting some of its water supply from Sukuta Treatment Plant. Additionally, NAWEC does not have any nitrate treatment procedure in place to reduce the level of nitrates in its water. The chart below shows the percentage level of boreholes encroached.

**Encroached:** We discovered that 31% of the NAWEC boreholes shared a fence with residents.
